National Transportation Safety Board

Marine Accident Brief

Sinking of Tall Ship *Bounty*

Accident no.	DCA-13-LM-003
Vessel name	<i>Bounty</i>
Accident type	Sinking
Location	Heel-over and abandon-ship: About 110 nautical miles southeast of Cape Hatteras, North Carolina, 33° 57.36' N, 73° 54.52' W Vessel last sighted: 123 nautical miles southeast of Cape Hatteras 33° 49. 6' N, 73° 44.3' W
Date	October 29, 2012
Time	Heel-over and abandon-ship: 0426 eastern daylight time (coordinated universal time -4 hours) Last sighting: 1920 eastern daylight time
Injuries	3 serious 2 fatalities (1 deceased crewmember recovered; captain missing and presumed dead)
Damage	Total loss; value estimated as \$4 million
Environmental damage	Minor, due to remaining fuel on board
Weather	At 0426: Winds 50–60 knots with gusts of 90 knots; air temperature 73°F; overcast, visibility of 1–2 nautical miles; seas >20 feet; water temperature 78°F
Waterway characteristics	Atlantic Ocean

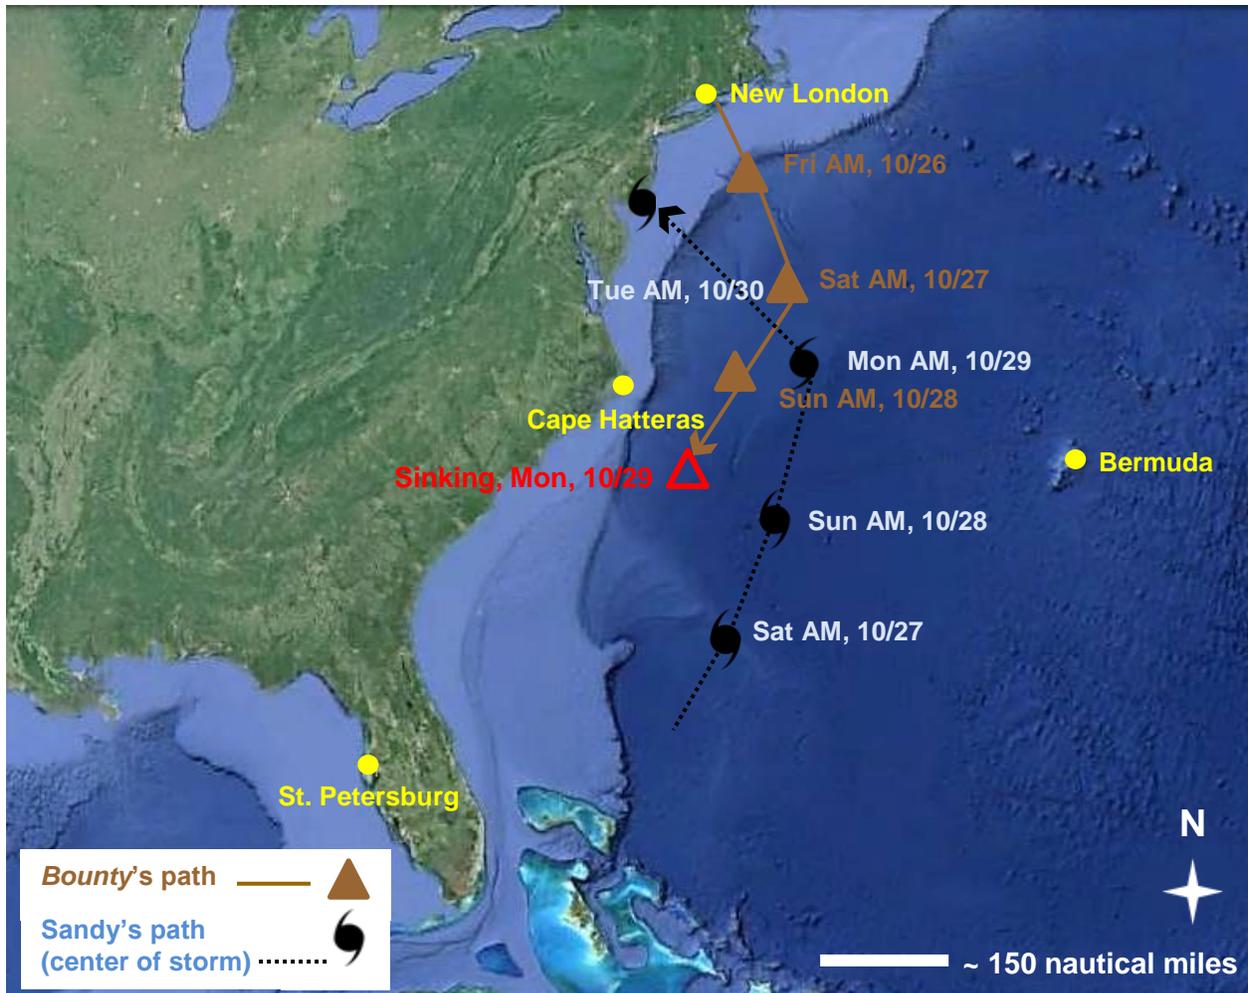
Satellite image showing the approximate southbound path of the *Bounty* and the approximate northbound path of Hurricane Sandy. (Background by Google Earth)

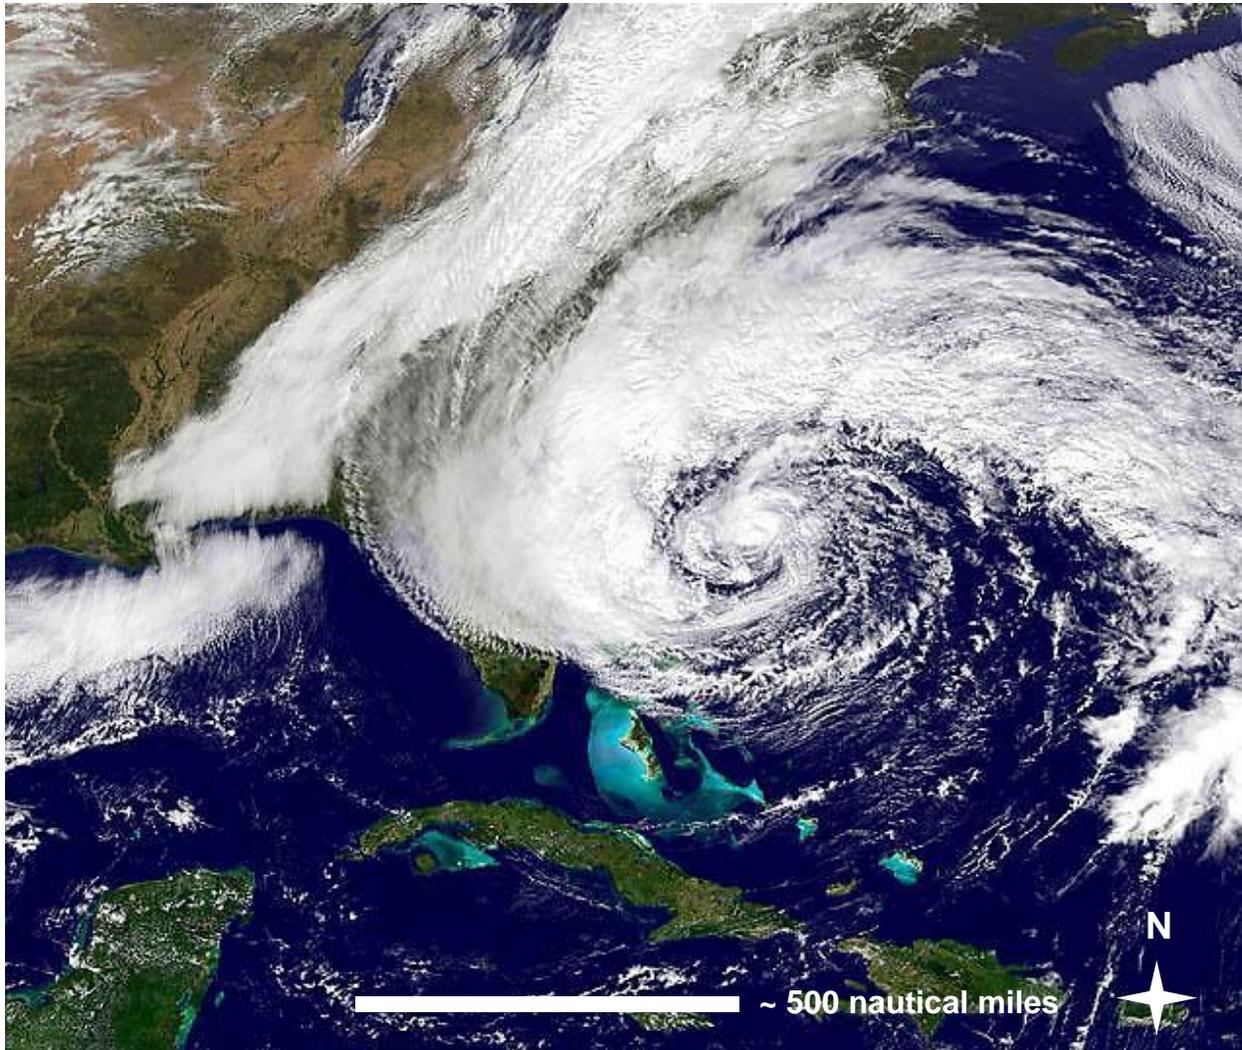
Satellite image of Hurricane Sandy on October 27, showing the large expanse of the storm. A National Weather Service advisory, issued at 1100 that day and sent in an email to the captain, stated that tropical storm-force winds extended up to 450 miles from the center of the storm and were already near the North Carolina coast.

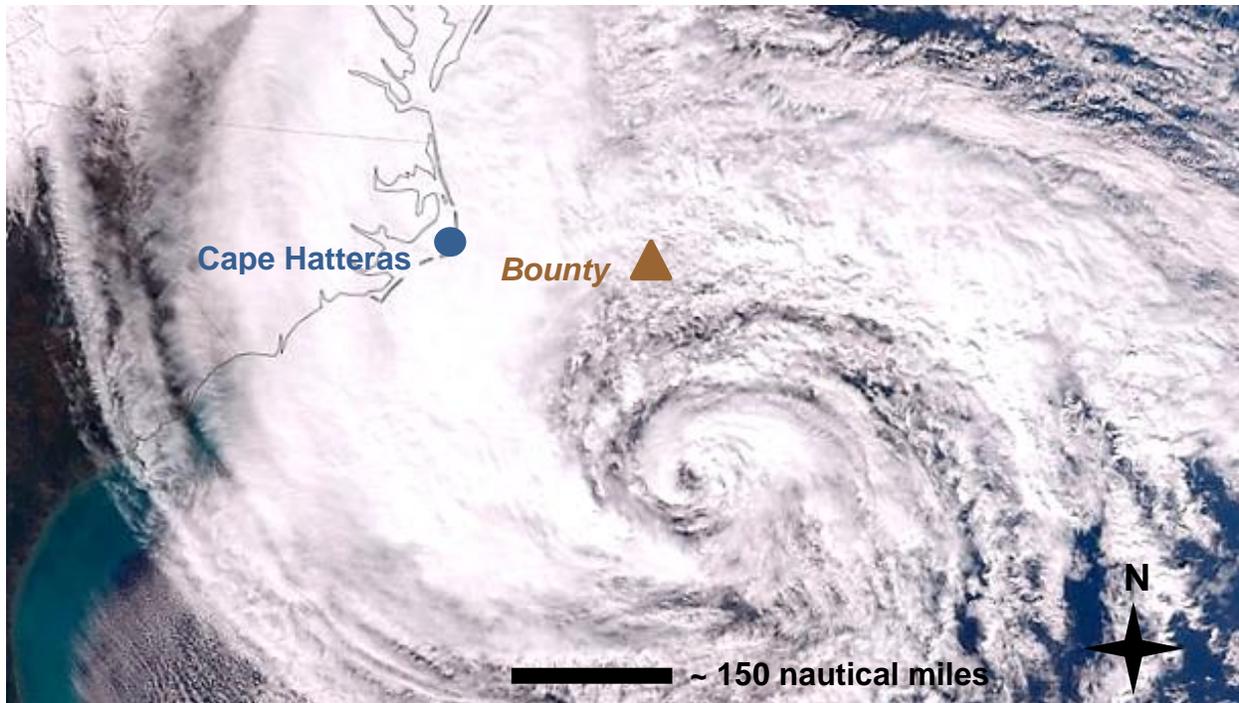
Satellite image of Hurricane Sandy, midday on Sunday, October 28. Overlaid on the image is the approximate position of the *Bounty* at that time.

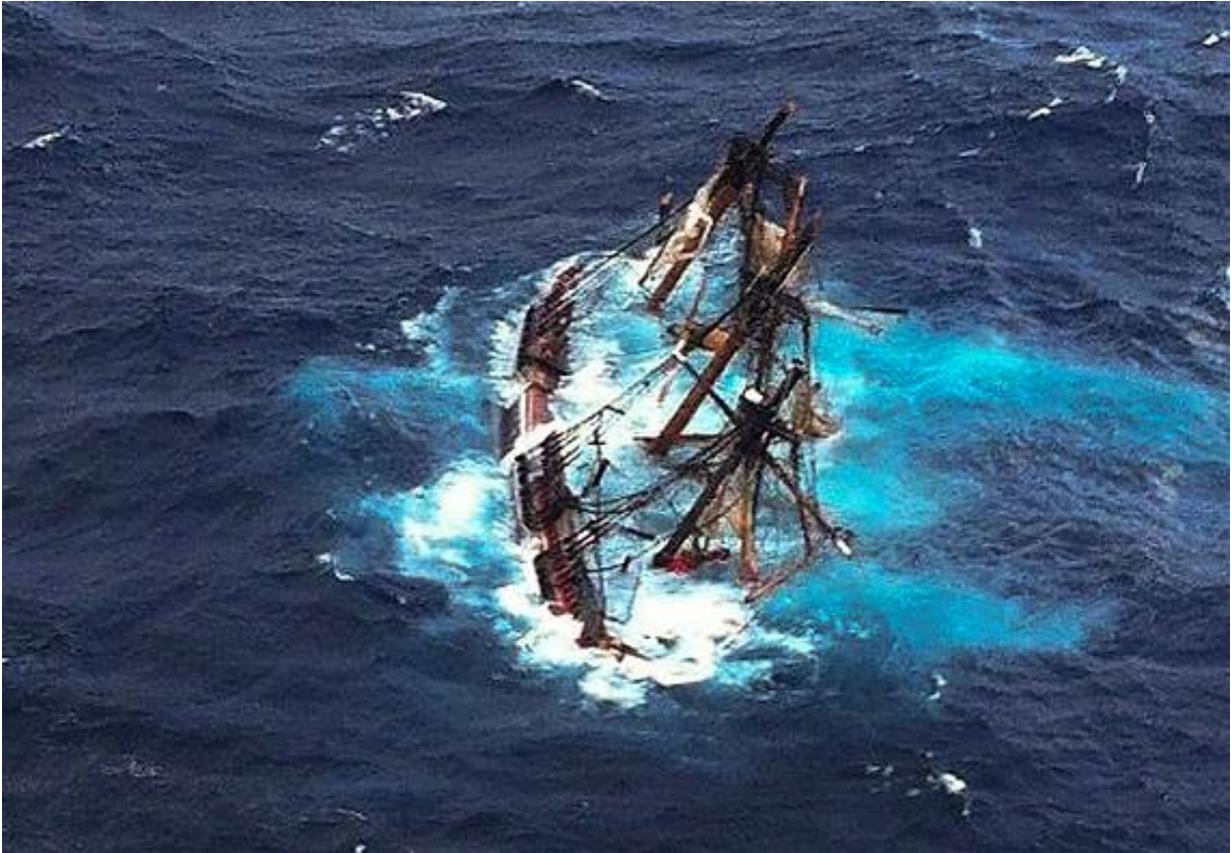
The *Bounty*, photographed from a Coast Guard aircraft above, before the vessel sank.

The last confirmed sighting of the *Bounty* was at 1920 on October 29, 2012, when the crew of a Coast Guard cutter saw the vessel lying on its side, awash in the sea, about 13 nautical miles southeast of where the crew had abandoned ship more than 15 hours earlier. It was an end to a voyage that should not have been attempted. To set sail into an approaching hurricane introduced needless risk. Further, most of the crewmembers were inexperienced and their complement was smaller than usual. In addition, despite the fact that the *Bounty* took on water
